TOOLBOX TRAINING

RIGGING RECORDABLE HAND INJURY

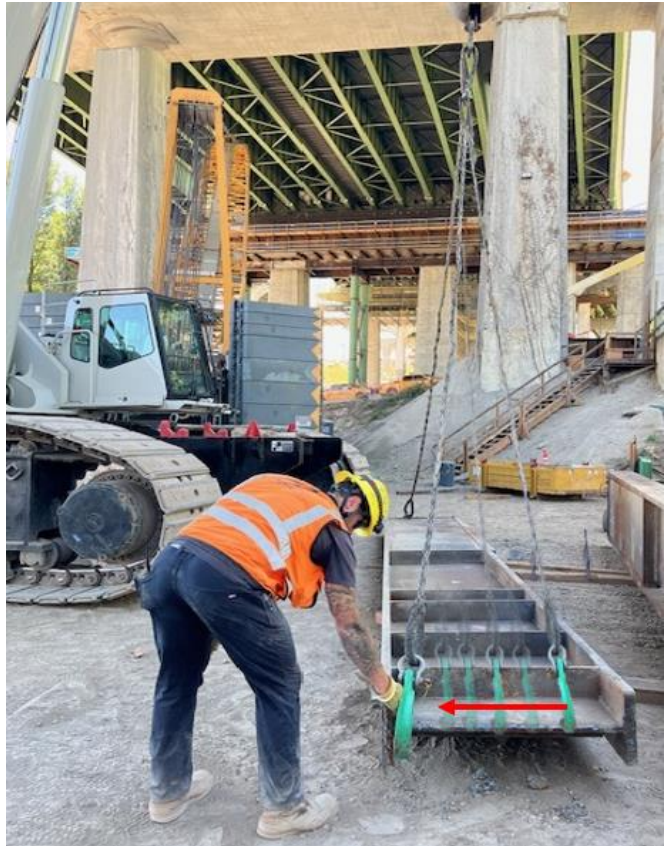
Foundry hooks were being used with a crane to reposition a beam laying on its side. The crane began to take load on the beam, and before the crane took the full weight, the foundry hook slid horizontally along the web and crushed the employee's hand between the hook and the bottom flange removing two fingers and fracturing a third.

- The work plan did not include I-beam clean up
- Incorrect rigging selected
- Unsafe body positioning while maintaining hand-on load during hoisting
- A tag-line was not used

If there is not enough information in your work plan, or if instructions are unclear, speak up and use your 'stop work' authority.

Direct physical contact with a suspended load creates additional risk and requires specific planning and control.

Tag lines are essential to manage load movement and must always be used!

Specialized rigging requires formal review and approval prior to it being used.
