TOOLBOX TRAINING

RIGGING RECORDABLE HAND INJURY

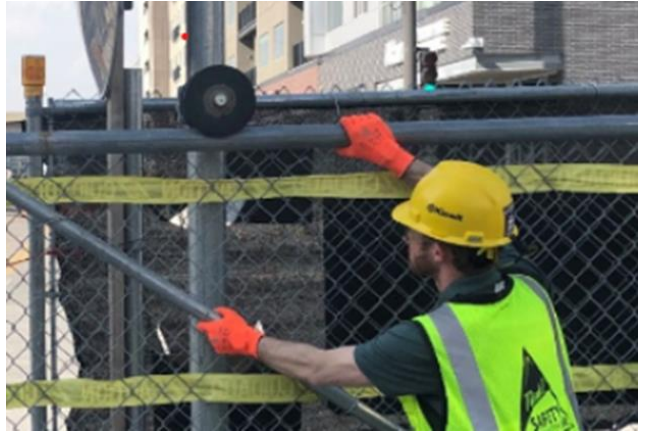
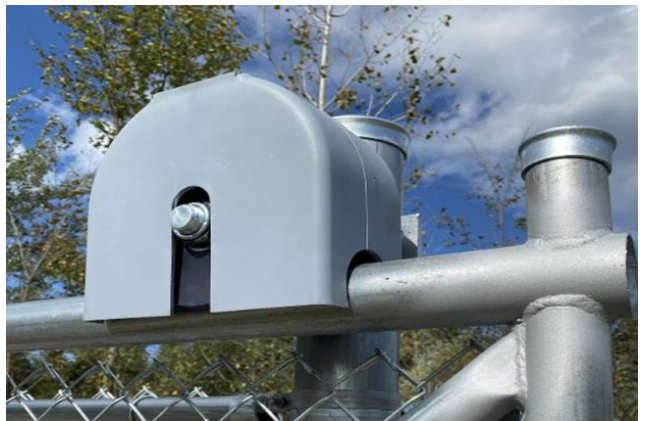
Two employees were closing an electric cantilever gate that had been powered off due to high winds during the shift, leading the employees to manually push the gate. While pushing the gate closed a gust of wind caused the gate to swing back and forth causing the employee at the back of the gate to grab the top rail to stabilize the gate while pushing it closed. As they continued to push the gate closed the employee at the back did not recognize the roller guide crush point and two of their fingers were caught between the roller and the gate frame.

- No Work Plan or Start Card for task
- Roller guide missing protective cover
- Inattention to hand placement
- High winds

Work plans / JHA / Operations Start Card are required for all operations / tasks to identify and eliminate hazards.

Guards/protective covers are essential to eliminating crush points.

When a change in our operations occur, then our plans should reflect the change to eliminate the new hazards.
